Final Design

Our goal: assembly of a safe and functional track mounted arm able to house recommended vacuum lift system

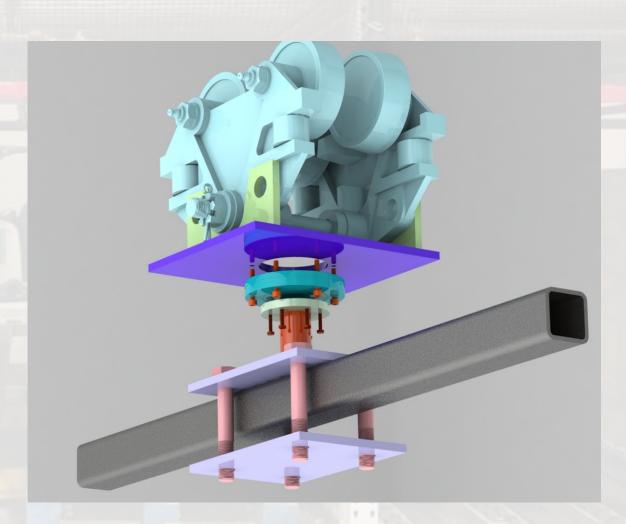
- Main components assembled
- After assembly, arm rotation test was deemed unnecessary
- Other design issues found upon assembly

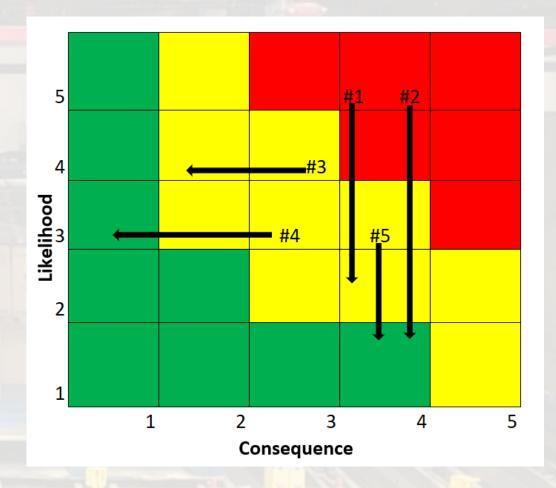
- Risk 1: Excessive beam deflection
 - Solution: ran Solidworks simulations using various materials
- Risk 2: Extreme shear forces on turntable
 - Solution: implemented heavy duty slew bearing rated higher than necessary
- Risk 3: Pinch points
 - Solution: protective casing and locks on movable parts

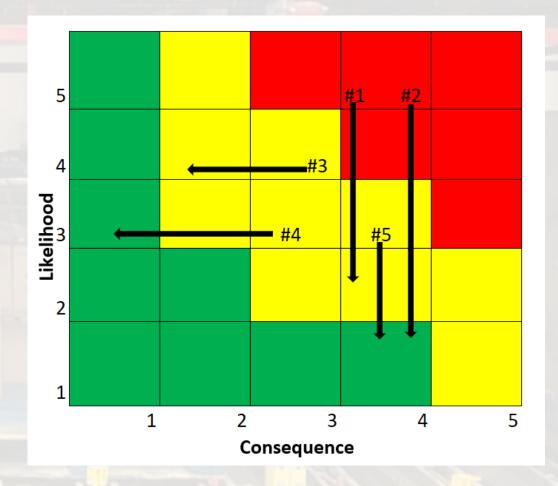
- Risk 4: Uneven distribution of vacuum head weight
 - Solution: position cups on secure frame
- Risk 5: Lack of suction while picking up items
 - Solution: adequate force applied to suction cups with weight of frame and correct pressure

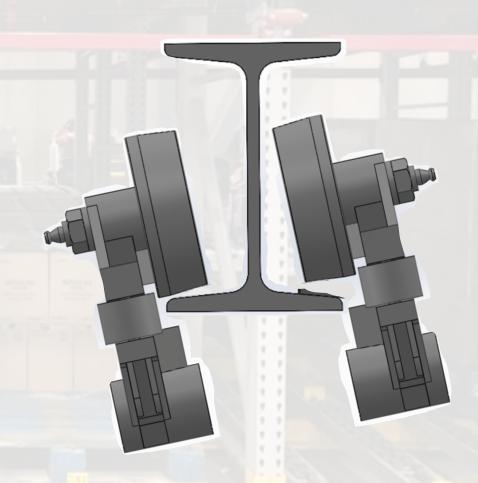
- Upon testing, it was noticed the trolley tilted as a result of an off centred load
- Not unsafe but appeared awkward

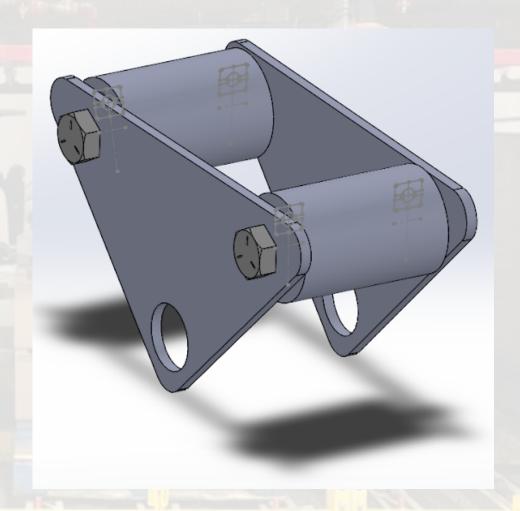
- A stabilizer piece was designed
- Two rollers pressed lightly against the bottom of the beam to support trolley without limiting movement

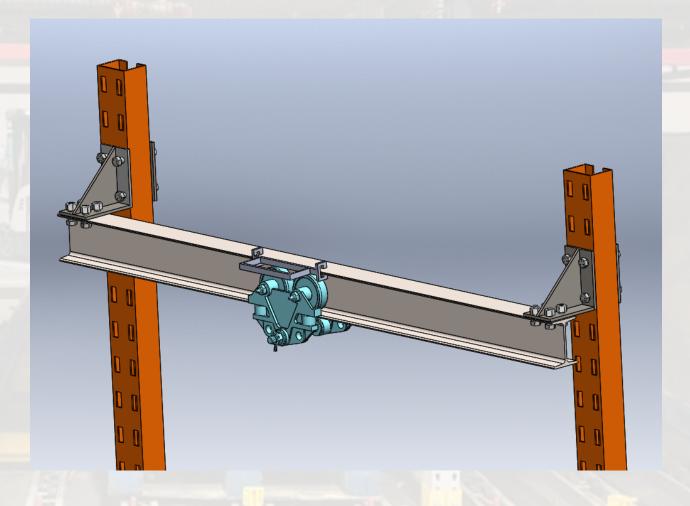
- A lock for the trolley will be installed to prevent unintentional sliding
- A lock for the arm will be installed to prevent unintentional swinging

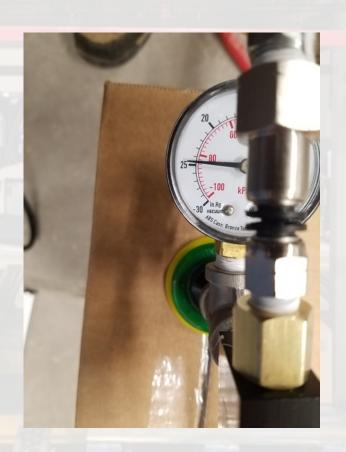
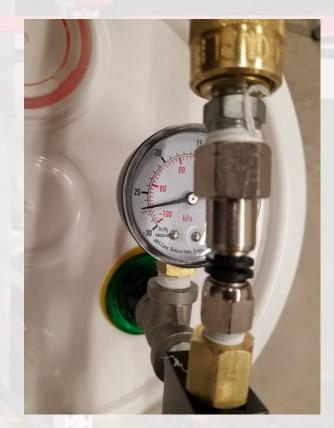
- Air flow from single pump split into two suction cups
- Vacuum tested on cardboard (with and without tape) and pails

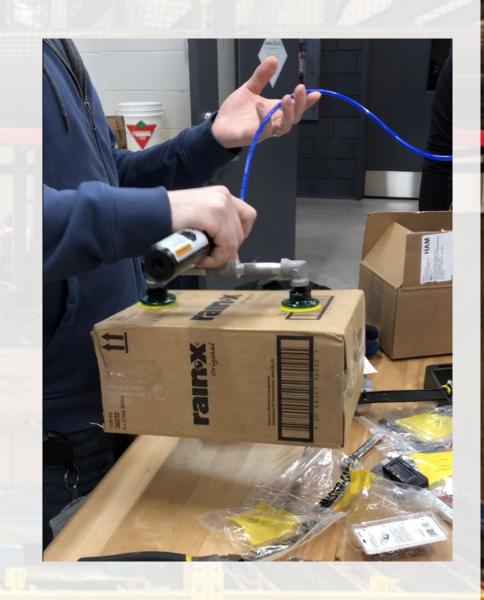
- An optimized suction system will be determined based on testing conducted
- Our recommendation: An optimized version of our testing or an off-theshelf vacuum automation system
